Non-martensitic Needle-like Structures on Ni-Ti Alloys - Occurrence and Origin

Abstract. In the present work the occurrence of needle-like structures that are observed on martensitic and austenitic NiTi after metallographic preparation and etching is described. The investigations show that the needle-like structures form in less than 10s during the etching process if solutions containing HF are applied. The needle-like structures look very similar to martensitic structures. Hence it is tempting to interpret them as martensite. Distinguishing the structures from martensite is not straightforward since standard analysis e.g. by EDX does not yield any differences in chemical composition of the needle-like structures and NiTi. Application of surface sensitive methods like grazing incidence X-ray diffraction clearly shows that the needle-like structures are different from martensitic structures of NiTi. In the present study the options of altering the etching process with the objective of avoiding the formation of the needle-like structures are presented and the origin of the needle-like structures is discussed.

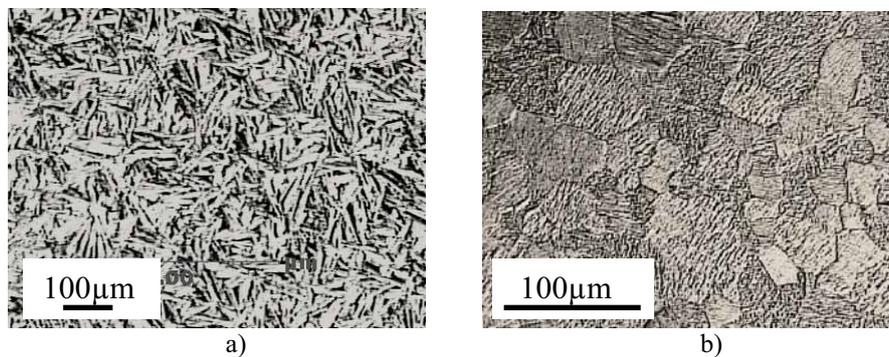
Fig. 1. NiTi sheet (martensitic, recrystallized) after etching in (a) solution 1 for 10s, with needle-like structures, and (b) solution 2 for 7s, with distinct grain boundaries.

The two different etching solutions yield significant differences in the resulting surface structures. While etching of a martensitic recrystallized NiTi sheet with solution 1 (concentrated acid) lead to the formation of the needle-like structures immediately (Fig. 1a), etching with solution 2 (water diluted) produced clearly visible details of the microstructure like grain boundaries (Fig. 1b).

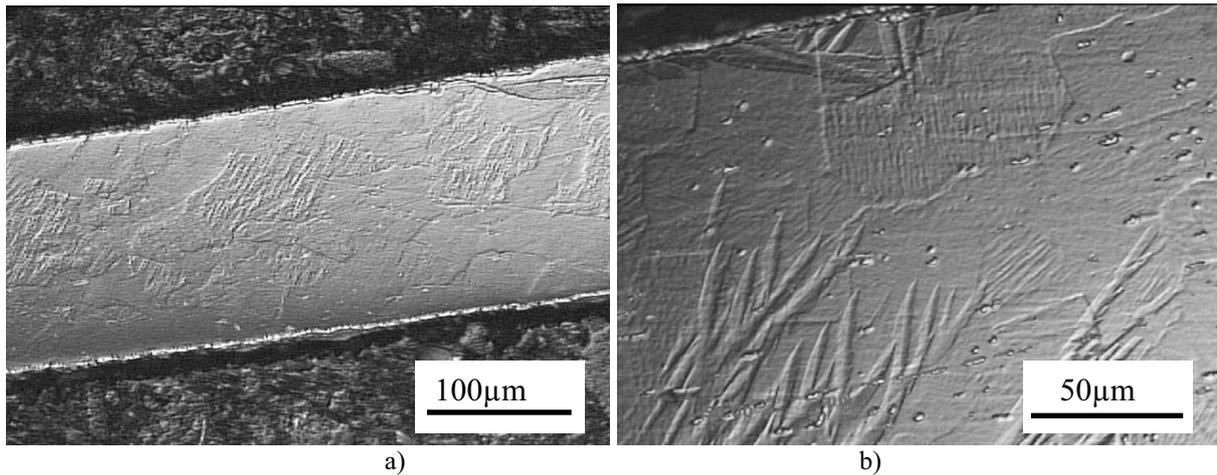
Fig. 2. NiTi wire (austenitic, recrystallized) after (a) etching in solution 2 for 5s with grain structure and (b) additional subsequent etching with solution 1 for 10s with both needle-like structures and grain boundaries.

Stepwise etching of a NiTi wire (austenitic recrystallized) with solution 2 (Fig. 2a) and afterwards with solution 1 (Fig. 2b) exhibits both the grain structure and the needle-like structure. From Fig. 2b it is obvious that the needle-like structure cannot originate from martensite, since it extends over the grain boundaries without changing orientation. There is no connection of the needle-like structure and the crystallography of the grains that is to be expected for martensite needles.

The fact that the needle-like structures are visible on the surface of one sample at the same time as the grain structure in Fig. 2b shows clearly the needle-like structures are surface structures and do not originate from nor display the bulk structure. Apparently the material that is dissolved during etching re-segregates on the surface of the sample immediately.

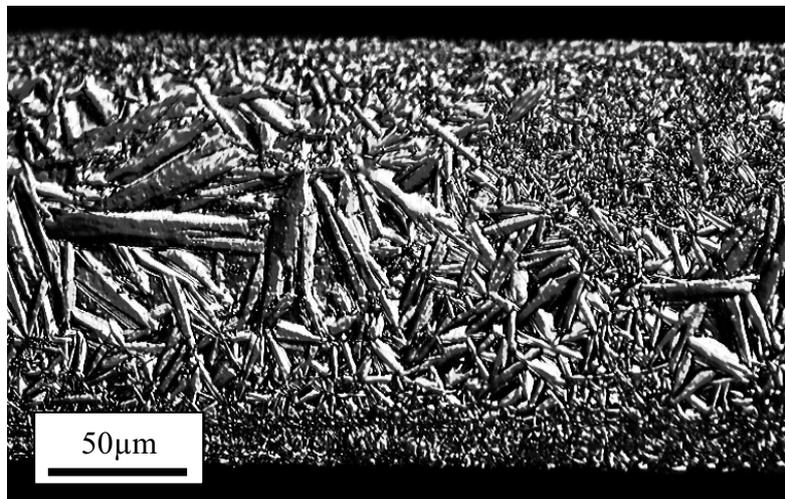
Fig. 3. NiTi wire (austenitic straight annealed) after grinding, polishing and etching for 7s in solution 1. The surface of the sample is fully covered with the needle-like structures. Etching was carried out immediately after polishing.

In the following investigation with the aim of identifying the origin of the needle-like structures only etching solution 1 was used. The needle-like structures emerged at the surfaces of all samples, independently of the crystal structure of the underlying phase and the adopted annealing procedure. Some of the samples were fully covered with the needle-like structure after etching, while on other samples the structures were only visible locally. The area fraction of the surface that was covered with the needle-like structures did not correlated with the duration of the etching process. A series of polishing and etching experiments showed that full coverage with the needle-like structures is attained, if etching is done without delay after the last polishing step (Fig. 3), while etching after several hours or days produces only partial coverage (Fig. 4). This is attributed to the self-passivation of NiTi that attenuates the etching/re-segregation processes. To identify the needle-like structures in more detail, further investigations were carried out to determine their composition and their crystallographic structure.

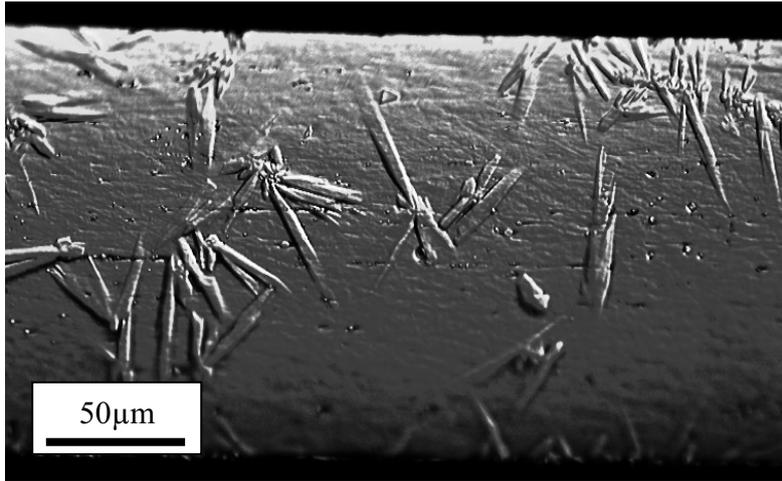
Fig. 4. NiTi wire (austenitic straight annealed) after grinding, polishing and etching for 7s in solution 1. The surface of the sample is only partially covered with the needle-like structures. Etching was carried out after an interval of several hours after polishing.

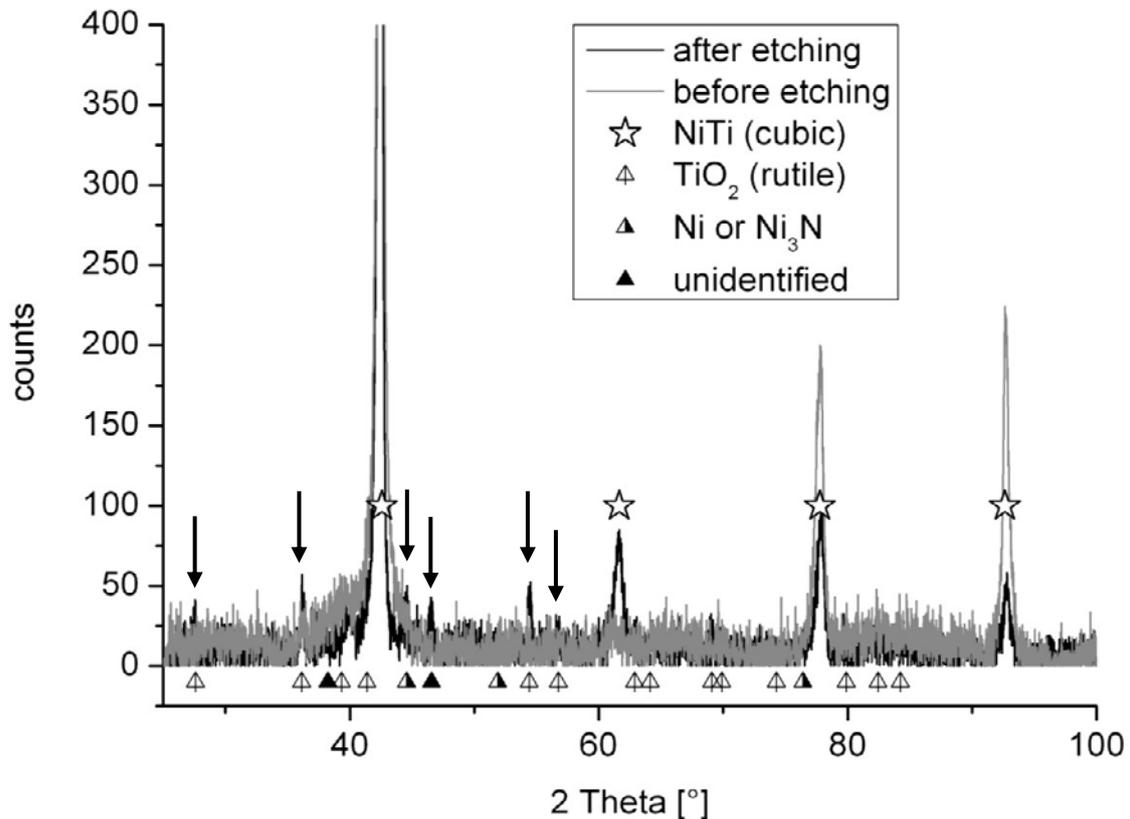
Fig. 5. Grazing incidence XRD spectra of two NiTi sheets (austenitic, recrystallized) after polishing and after polishing and subsequent etching with solution 1, respectively. The major peaks correspond to the cubic austenitic NiTi phase. Additional peaks (marked by black arrows) indicate the presence of TiO₂ (rutile), a variant of hydrogen titaniumoxide hydrate (marked as 'unidentified') and of Ni (cubic) or/and Ni₃N.

For a detailed analysis of the phases in the surface layer, grazing incidence X-ray diffractions was applied. In Fig. 5 for both an austenitic recrystallized NiTi sample after polishing (grey) and for a sample treated with the same parameters, but with additional etching after polishing (black) are shown in superposition. The peaks corresponding to the cubic austenitic NiTi phase are identical for both samples and confirm that there is no martensite on the surface. Thus, a martensitic origin of the needle-like structures can be excluded.

The extraordinarily fast formation of stable TiO₂ in the rutile modification during etching in less than 10s is unexpected. Rutile typically forms during annealing at elevated temperatures. It is supposed that rutile is not forming directly during etching, but is converted from the less stable and defective Ti and oxygen containing compounds like the hydrogen titaniumoxide hydrates. The conversion of the components to rutile appears to be time dependent, or activated/accelerated by the X-ray beam, since longer measurements times with grazing incidence X-ray did enhance the peaks of rutile on the cost of the peaks corresponding to the hydrogen titaniumoxide hydrates. The mechanism of TiO₂ formation is not clear, but it appears possible that the available Ni acts as catalyst during the reaction.
